REBUILDING UKRAINE

Kyiv Center of Reconstruction and Ecological Restoration/Kyiv, Ukraine

UCA Canterbury
School of Architecture and Design
MArch 2024

Kyiv Centre for the Reconstruction
and Ecological Restoration

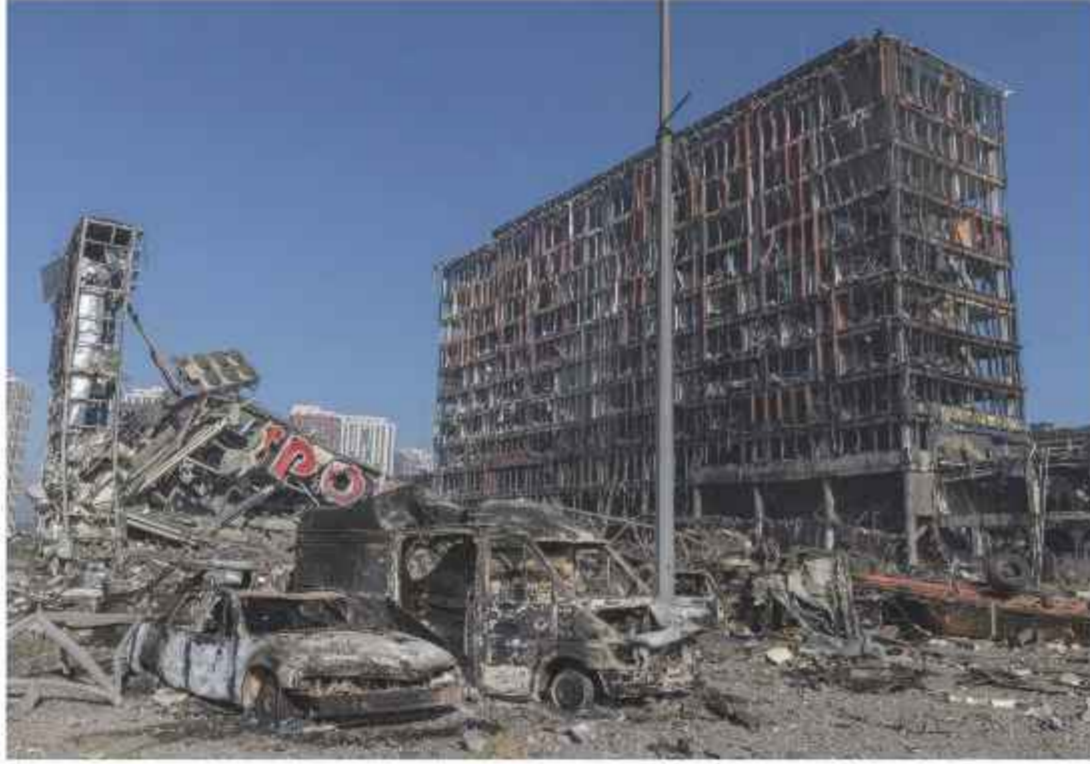
1 - Pravda Avenue, 47

Steel structure

Reinforced concrete floor

On March 20, 2022, the armed forces of the Russian Federation bombed the "Retroville" shopping center located in Kyiv. The "Retroville" shopping center had dimensions of 120,334 cubic meters, an area of 86,000 m2 and contained more than 250 stores.

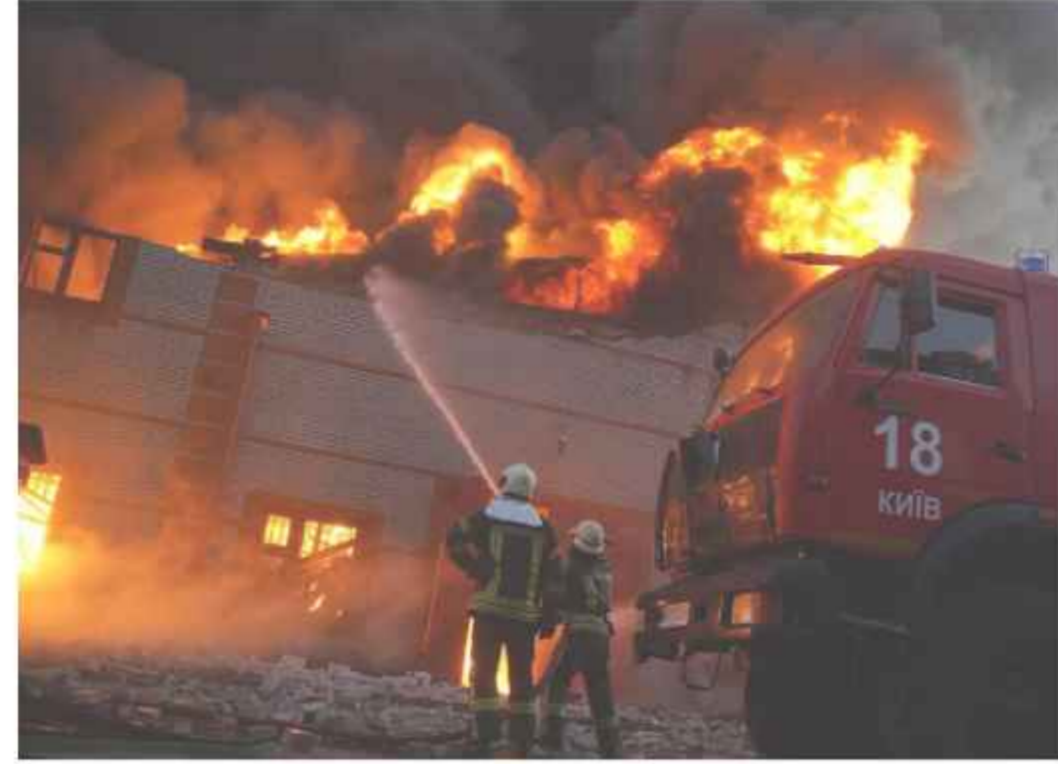
2 - St. Berkovetska, 1

Brick

On March 17, 2022, the Russian occupiers shelled the Sviatoshyn district of Kyiv, as a result of which several fires broke out, including in the warehouses of the "Ardis" bicycle factory, where a projectile hit, resulting in a fire on an area of about 10,000 m2.

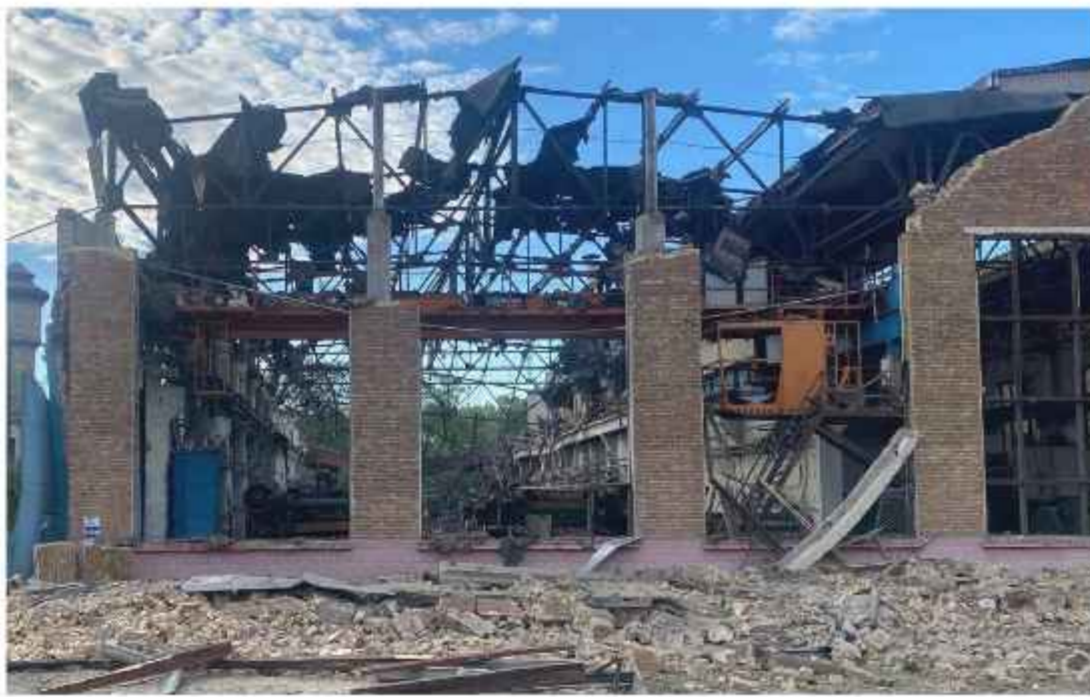
3 - St. Almaty, 74

Steel

Brick

On the morning of June 5, five rockets landed on the left bank of Kyiv. Four of them got to the Darnytskyi Wagon Repair Plant at DVRZ. According to Russian statements, the targets of the strikes were allegedly "T-72 tanks supplied by Eastern European countries and other armored vehicles located in the buildings of the carriage repair enterprise.

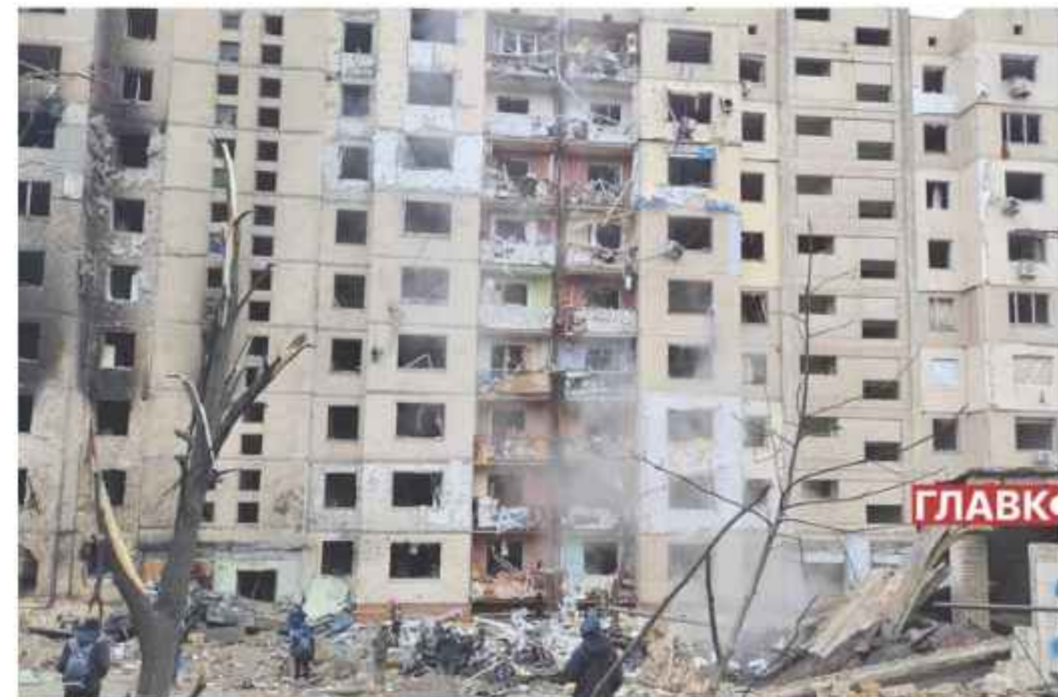
5 - St. Kudryashova, 7

Concrete panels

Tiles

On January 2, 2024, the Russian invaders attacked the capital of Ukraine with massive rocket fire. The three entrances of the residential apartment building, which are completely burnt out, are uninhabitable.

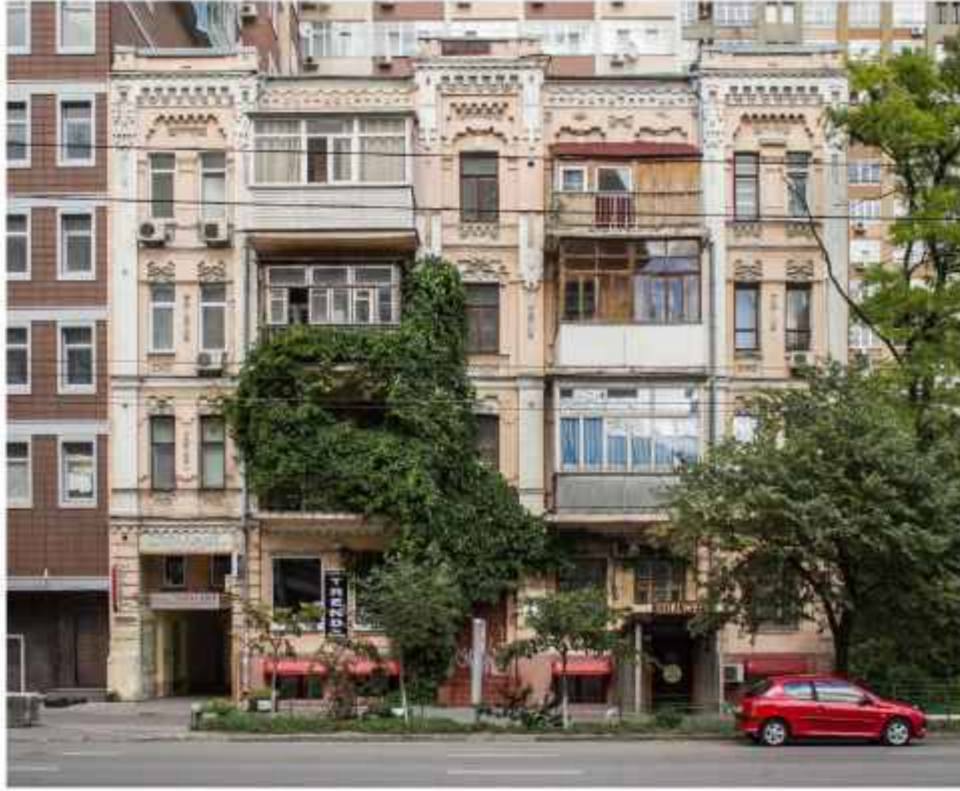
The facade of the building at Zhilyanska street in the environment, 2019

The house on Zhilyanska Street, 116-A is a residential building in the Shevchenkiv district of Kyiv, on Zhilyanska Street. It was built at the end of the 19th and the beginning of the 20th centuries, but, despite some architectural and historical value, it does not have a protective status.

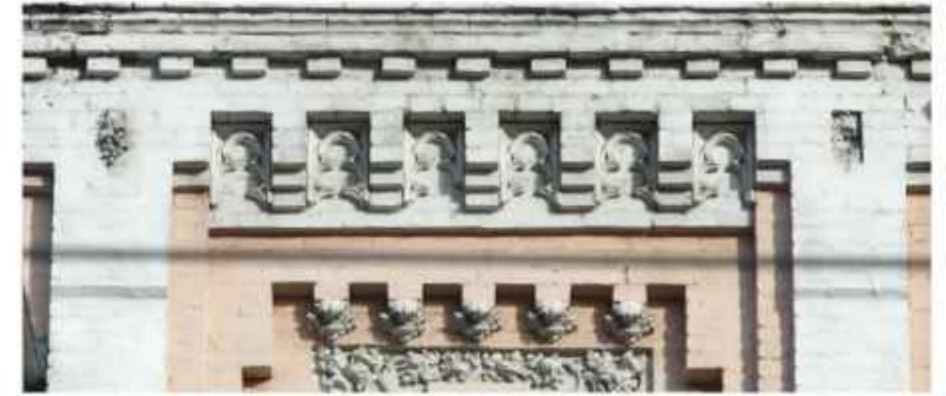
Brick facade with risalites, decorated with pilasters

The house was built in the popular at that time "brick style". The front facade has a symmetrical three-axis composition inherent in the brick style, formed by risalites, decorated with pilasters. The facade is quite richly decorated with stucco neo-Gothic inserts above, below and between the windows, a toothed cornice and inter-floor belts. The space between the risalites is occupied by two rows of balconies, from the second to the fourth floor. The windows are rectangular, in the side bays — narrow, paired.

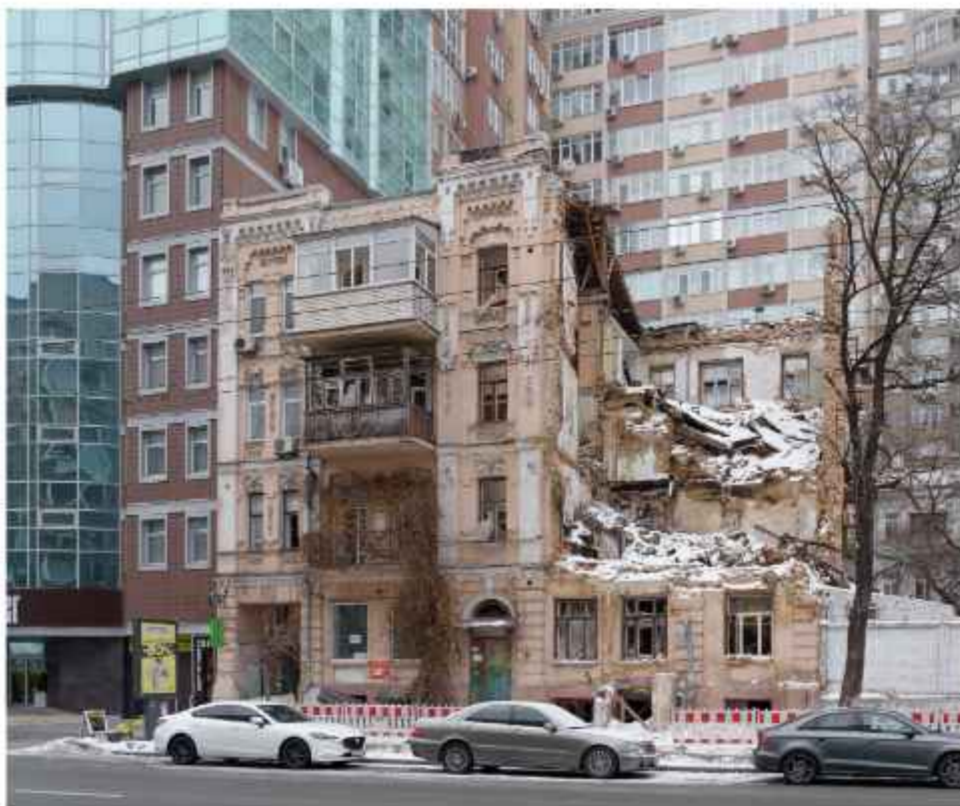
The building after the shelling, front view, 2020

The building suffered significant damage on the morning of October 17, 2022, when Shahed-136 kamikaze drones attacked Kyiv, hitting the building caused a fire and the collapse of part of the structure. The mayor of Kyiv declared that the building was recognized an emergency and could not be restored.

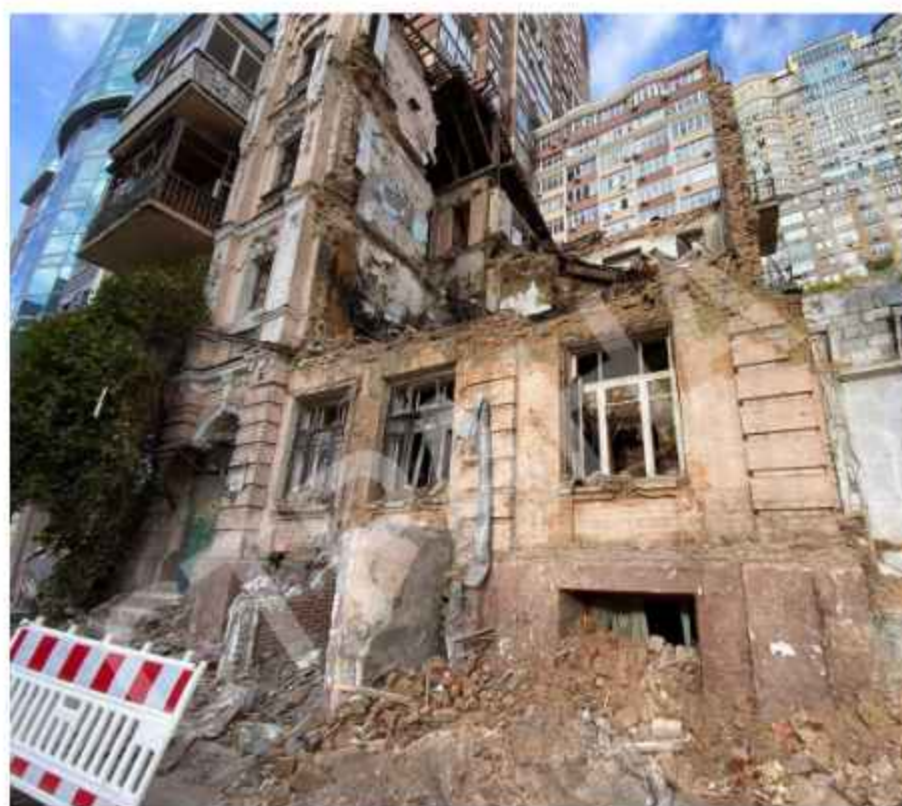
The building after the shelling, lower part of the building, 2021

The 1st, 2nd, and 3rd floors of the right part of the building were destroyed, the back wall was preserved, and the outer wall of the building on the right side partially collapsed. Garages and boiler rooms to the right of the building were destroyed by the impact.

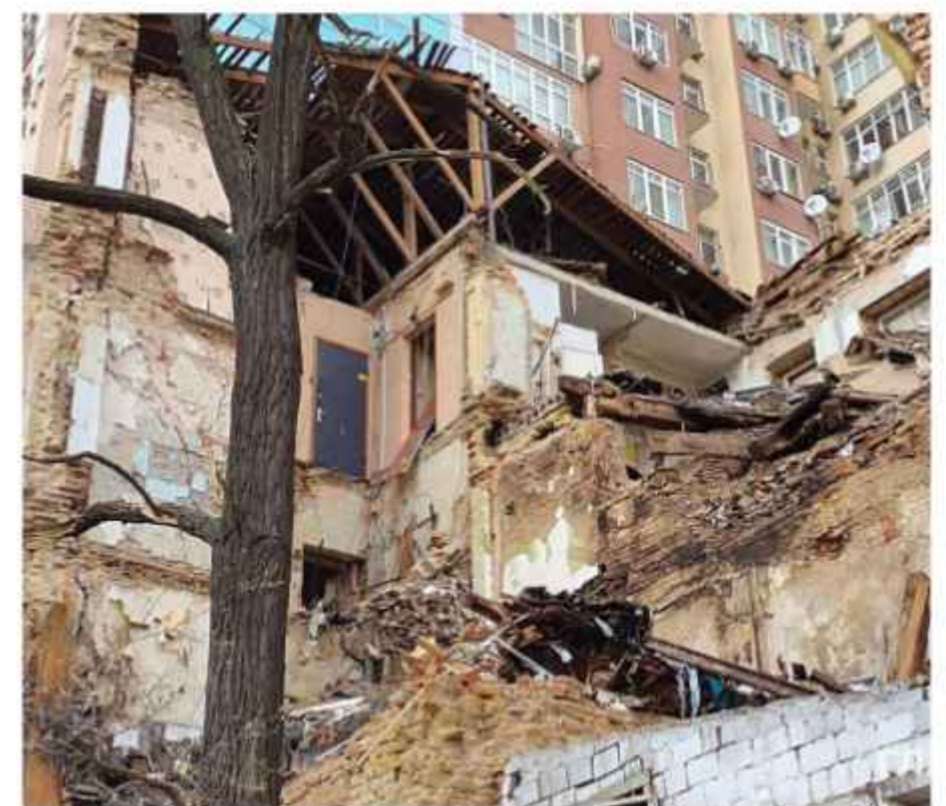
The building after the shelling, upper part of the building, 2021

Internal structures that have endured. The stairwell collapsed, there is no access to the surviving apartments. There are original wooden floor beams, in some apartments the floor structures have been reinforced or replaced with hollow concrete slabs. The roof lining has collapsed, the attic floor is missing. The roof structure is wooden with zinc roofing.

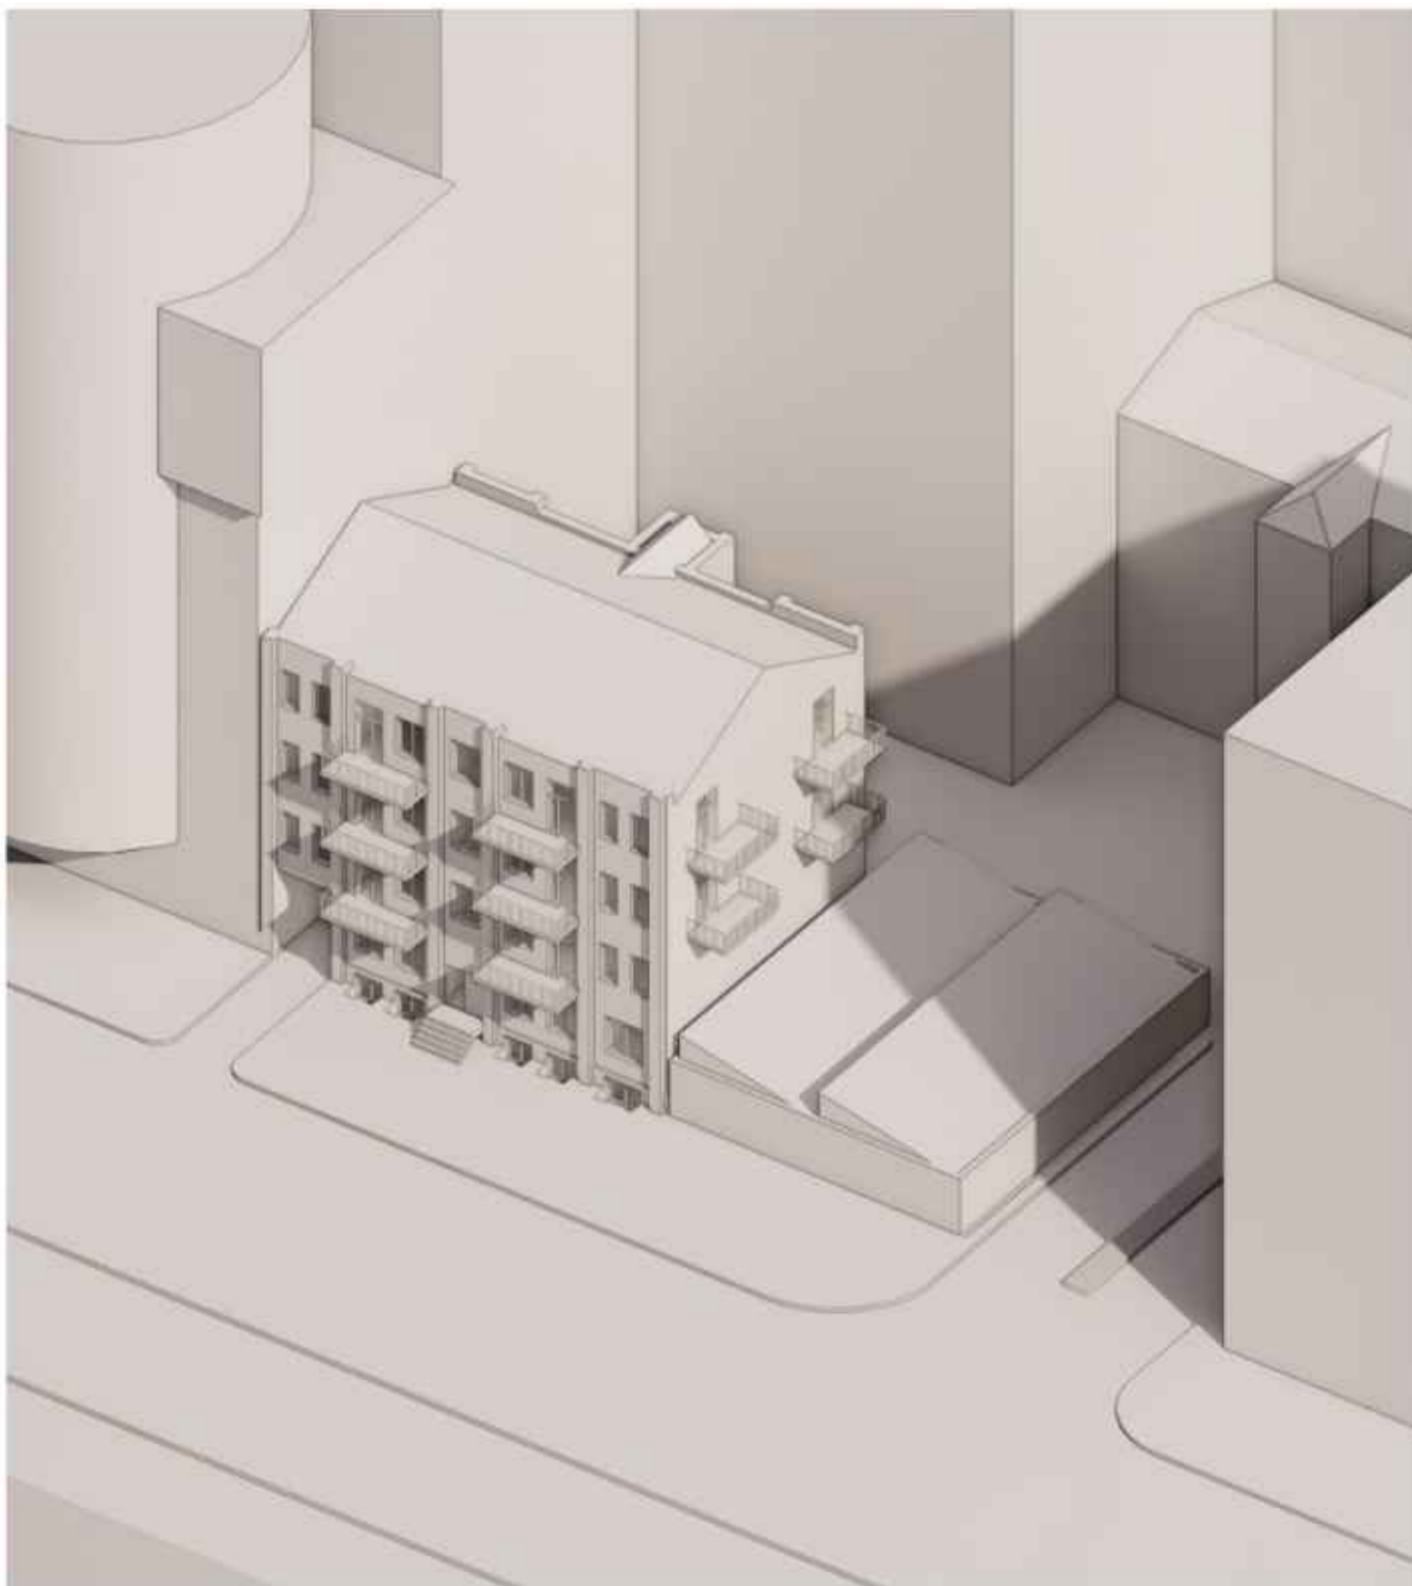
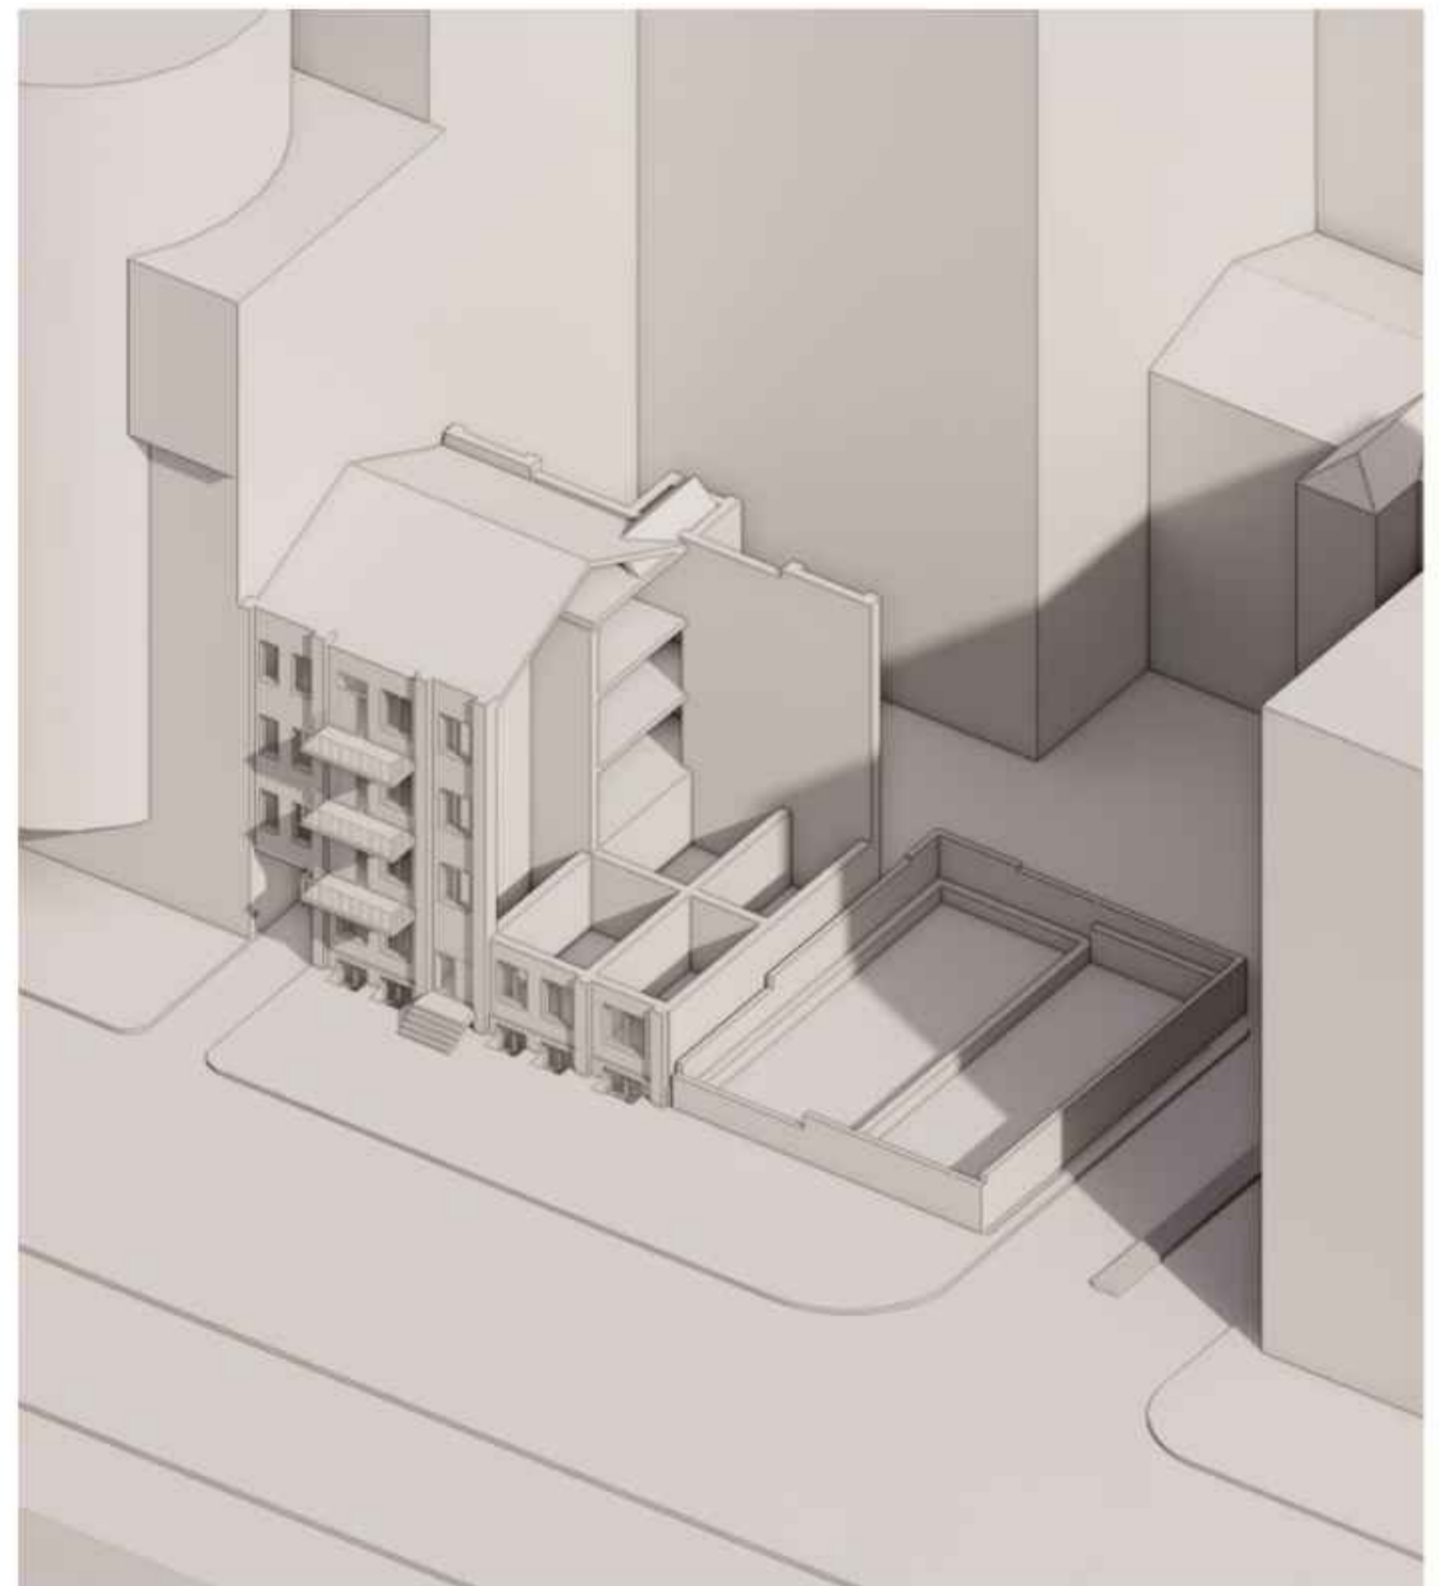
The building before/after destruction

The left side of the previous building actually remained, the central stairwell collapsed, only the walls of the basement and the ground floor survived on the right side of the building. During the redevelopment, the demolition of the original brick walls is avoided, the stairwells are moved from the center to the perimeters of the building. In general, the building contains the following program blocks: workshop, employees' offices, exhibition gallery, lecture hall, study room, communal premises, etc.

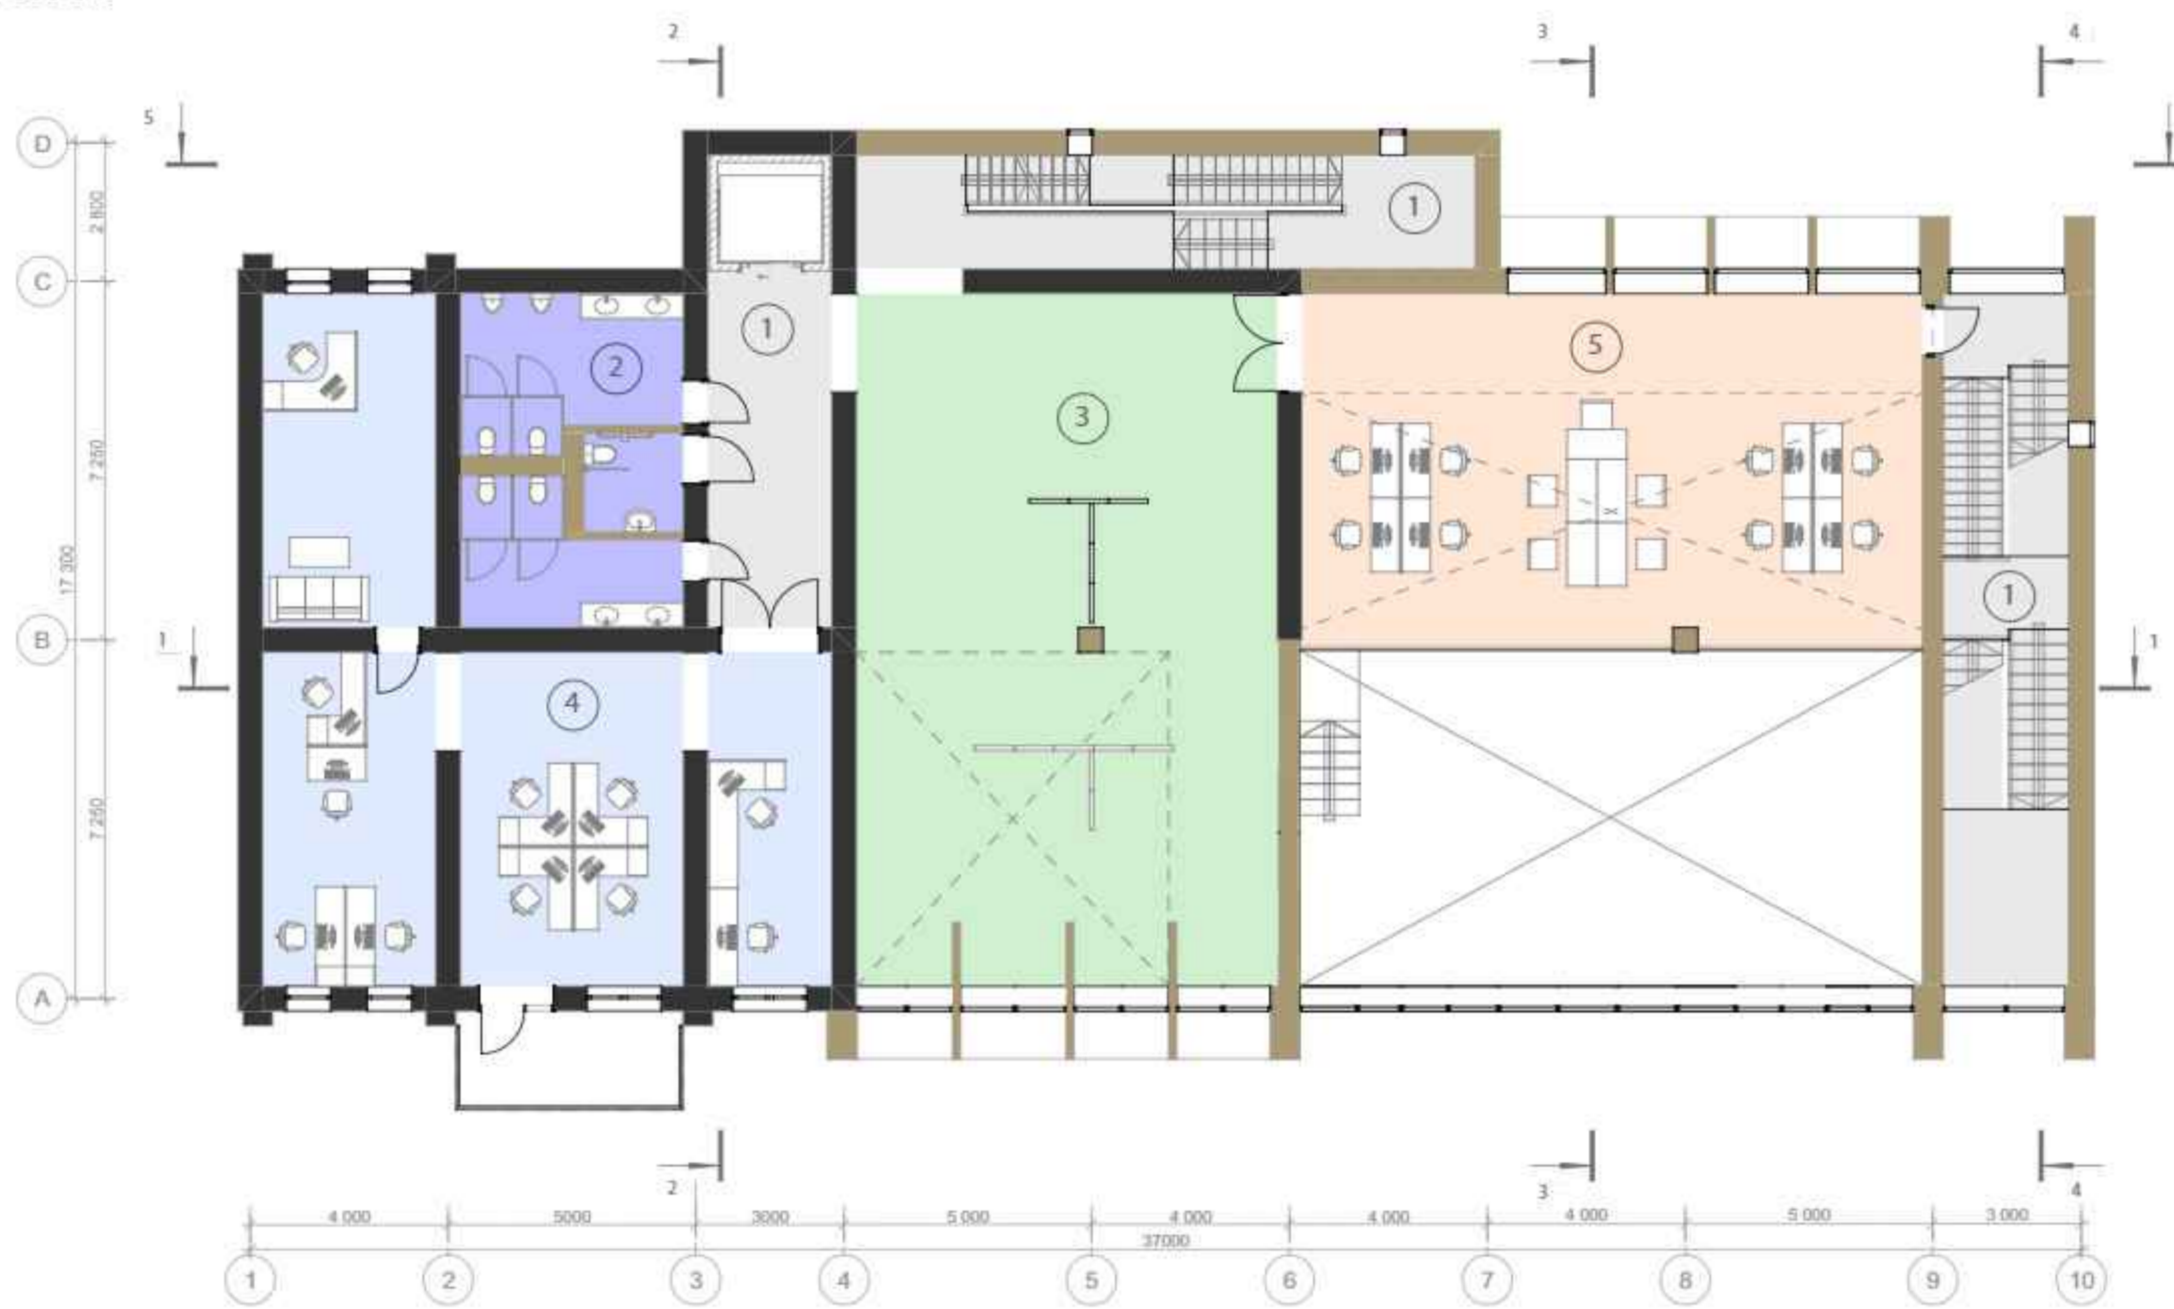
1st floor

- ① Vertical and horizontal communications, communal premises
- ② Toilets
- ③ Exhibition hall
- ④ Offices (bureaucratic apparatus)
- ⑤ Workshop

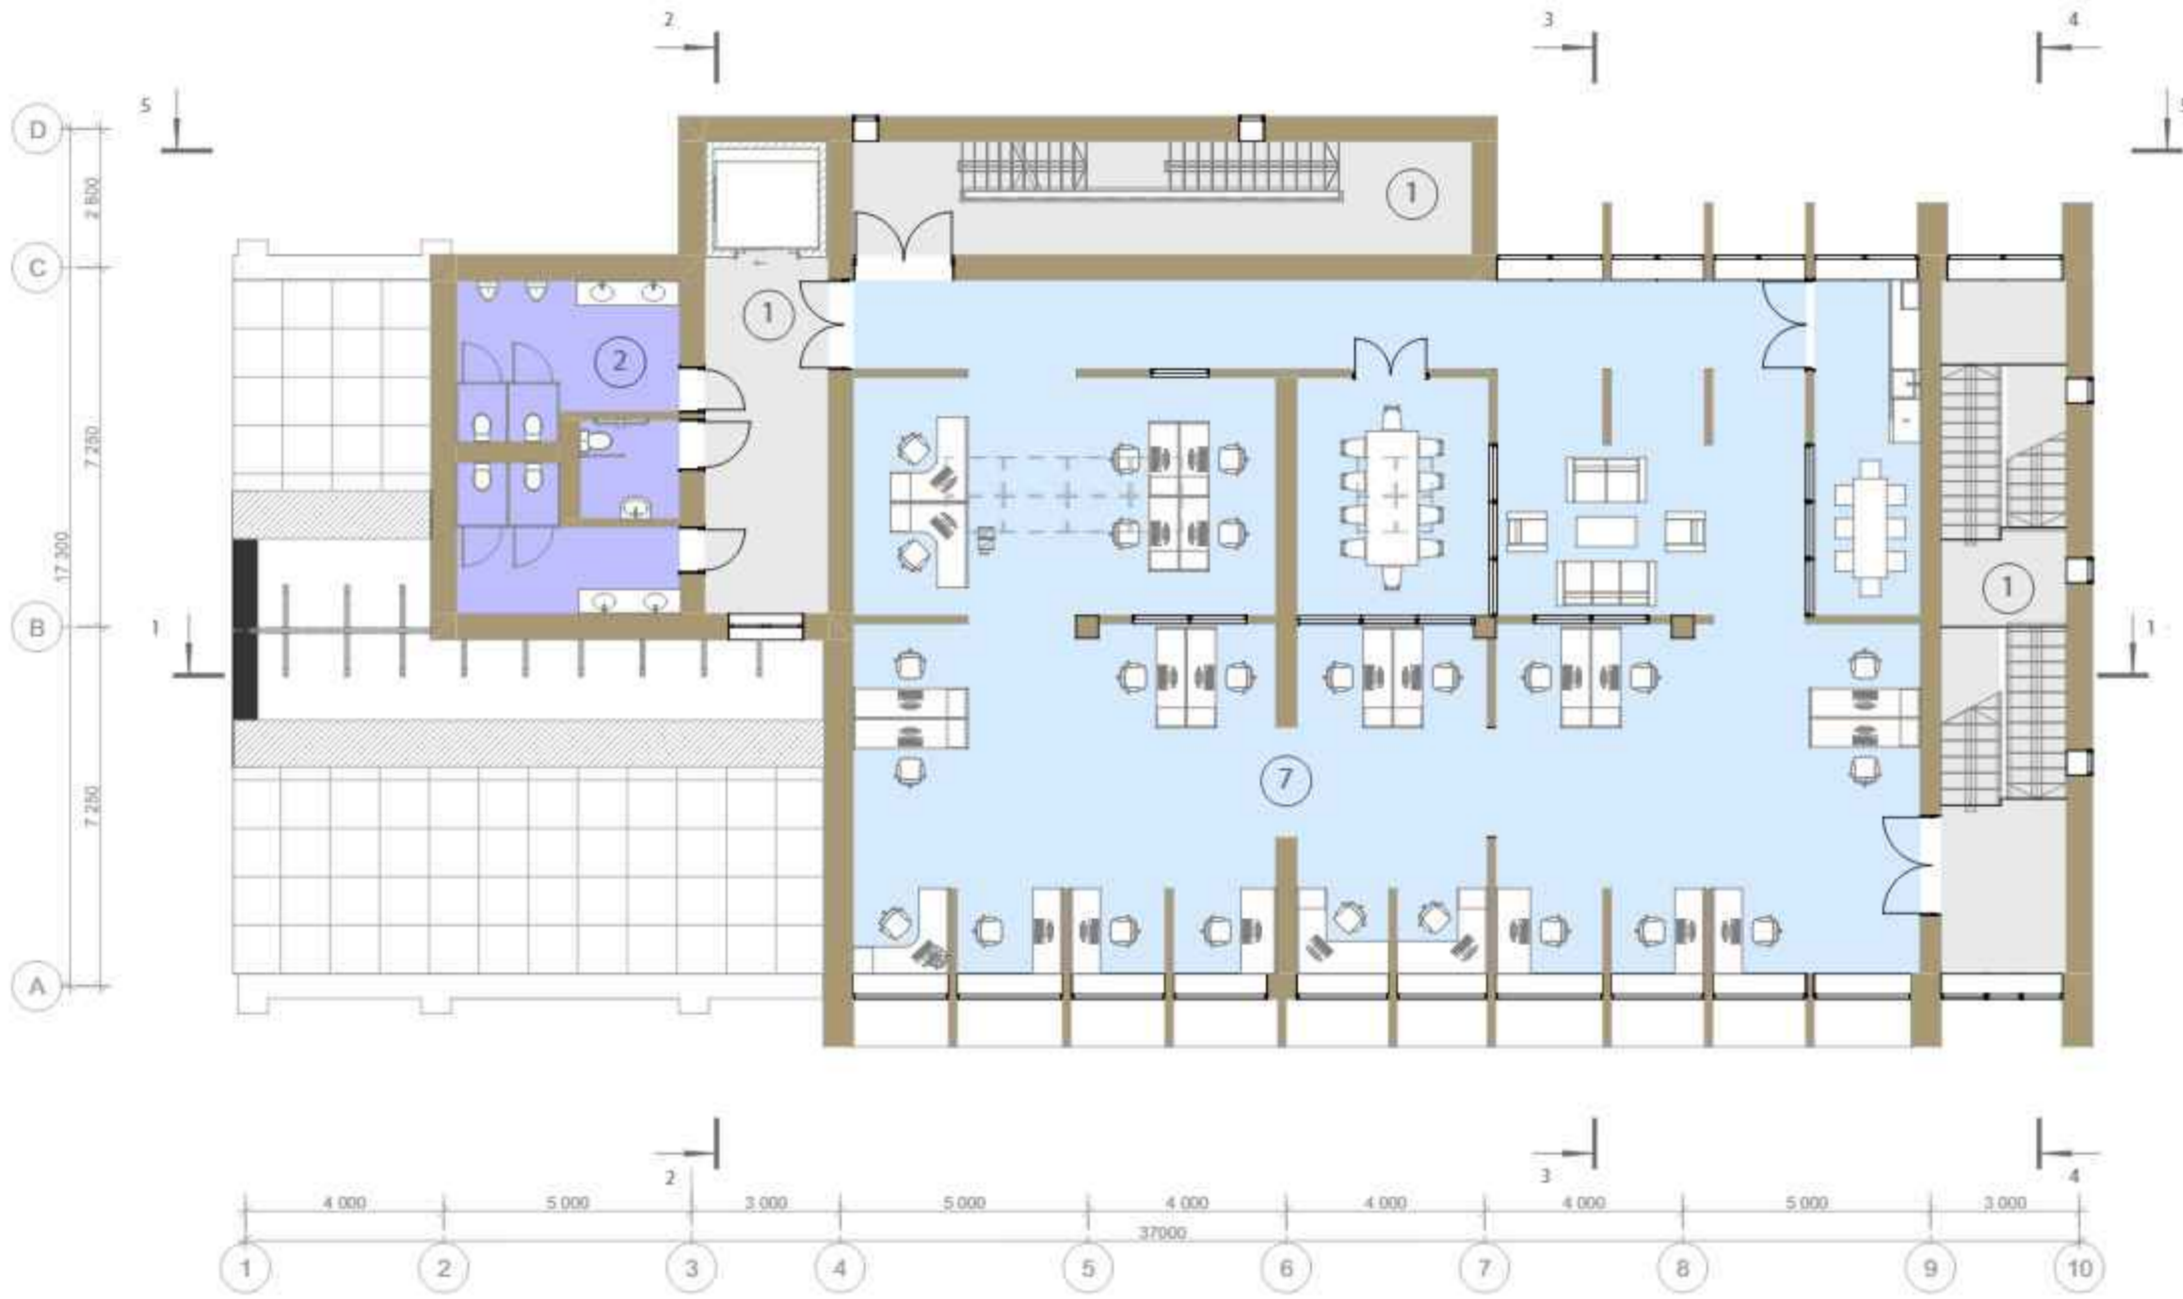
4th floor

- ① Vertical and horizontal communications, communal premises
- ② Toilets
- ③ Exhibition hall
- ④ Offices (bureaucratic apparatus)
- ⑤ Theater
- ⑥ Study rooms
- ⑦ Office of researchers
